Sector 3, Aiken's Village, Stepaside, Co. Dublin

Quality Audit

Project number: 60617802
PR-424832-ACM-XX-XX-RP-CE-00-0001

August 2022

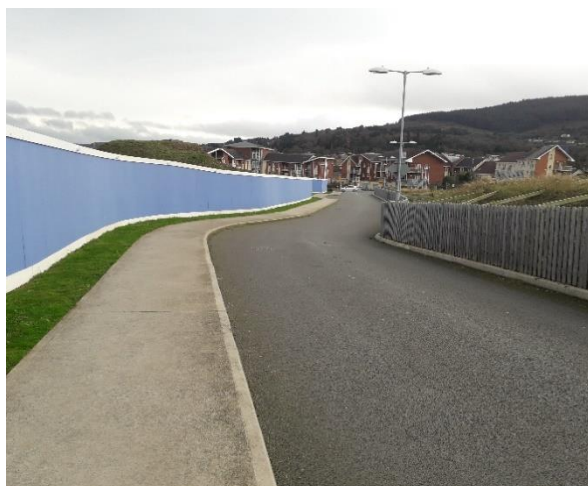
Figure 2.2 Atkinson Drive

- Atkinson Drive is a two-way carriageway with a 20 km/h speed limit and serves an existing housing estate to the north of the development site.
- There is a parking layby located along the east side of Atkinson Drive adjacent to the proposed development site.

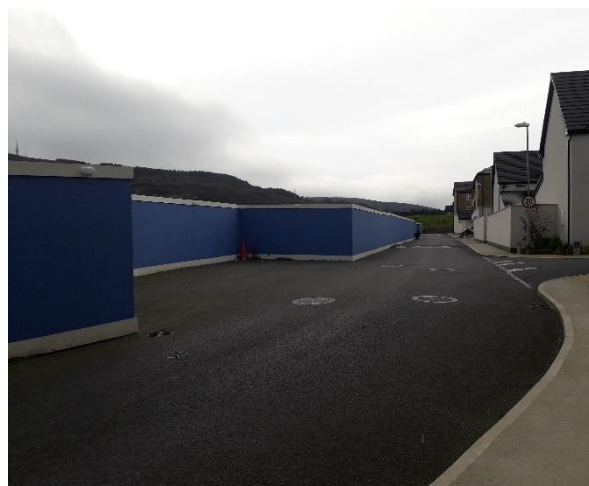
Figure 2.3 Thornberry Road

- Thornberry Road forms a junction with Atkinson Drive and bounds the site to the north. This road is approximately 4.5m in width and serves dwellings located on Thornberry Close and Thornberry Drive.
- Village Road, which bounds the development site to the south, forms a junction with Atkinson Road. This is the main access road through Aikens Village where it serves a number of residential estates.
- Village Road is a two-way carriageway with a speed limit of 50 km/h.
- There are two bus laybys located on both sides of Village Road approximately 30m to the west of its junction with Atkinson Drive.
- Access to Cluan Shee residential development is located off Village Road opposite the proposed development site.

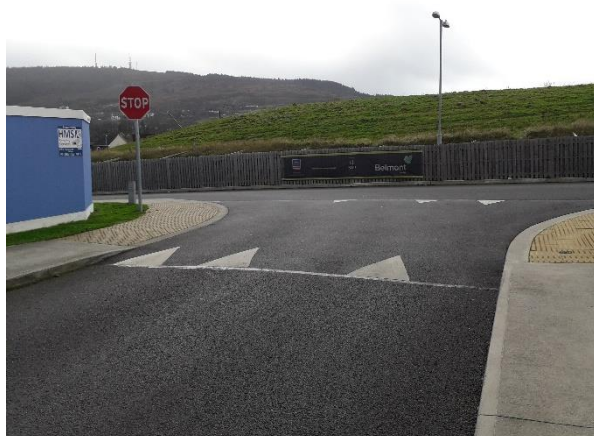
Figure 2.4 Junction between Thornberry Road and Atkinson Drive

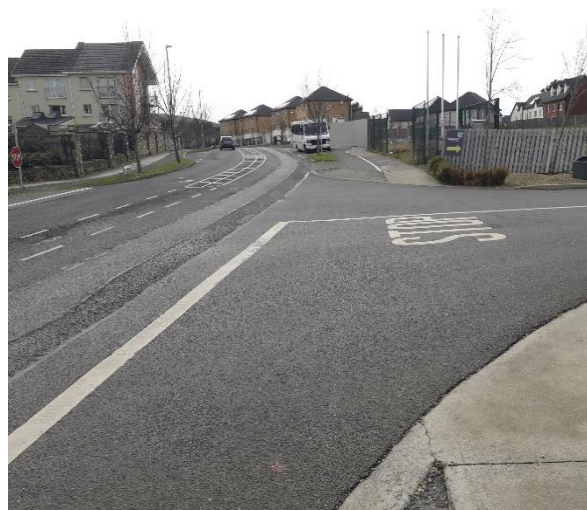
Figure 2.5 Informal crossing at the junction between Village Road and Atkinson Drive

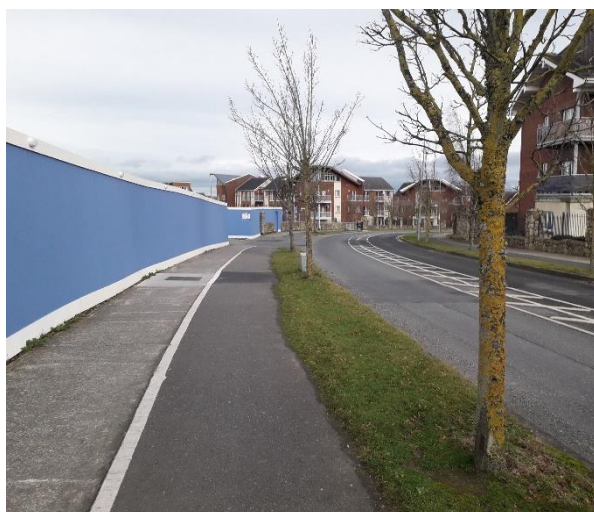
Figure 2.6 Shared pedestrian/cycle path along the site's frontage with Village Road

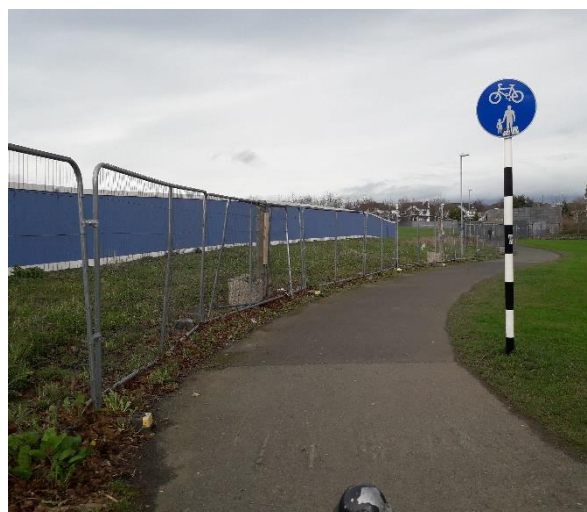
Figure 2.7 Shared path between Village Road and Fencarrig Avenue

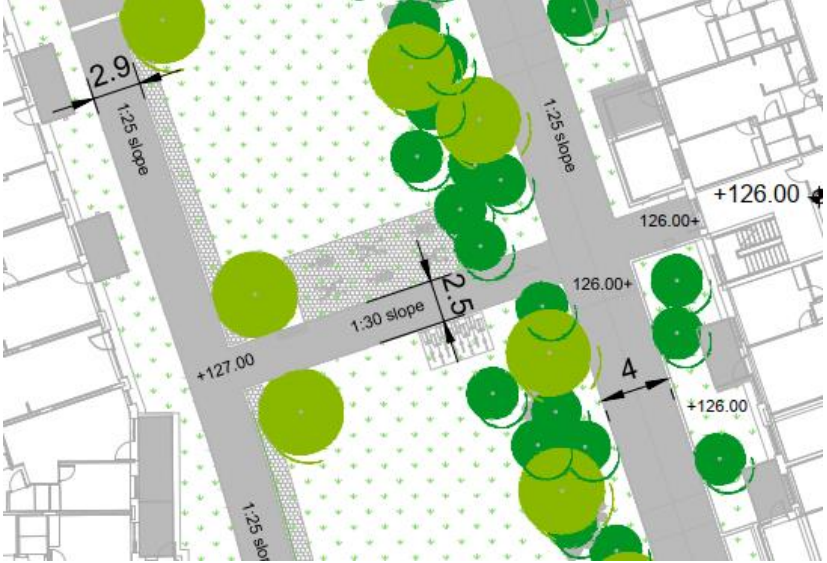
4.1.1.1 Problem	
Location	Throughout site
Drawing	Proposed General Arrangement
Summary	Width of Shared Pedestrian and Cycle Facilities

<p>Figure 4.1: Proposed Shared facilities</p>	
Description	
All the internal paths have been noted at shared facilities on the drawings. However, some of the shared paths are 2.5m. This width may result in conflicts between passing cyclists and pedestrians resulting in collisions.	
Recommendation	
The shared pedestrian/cycle path should be 3.0m as a minimum.

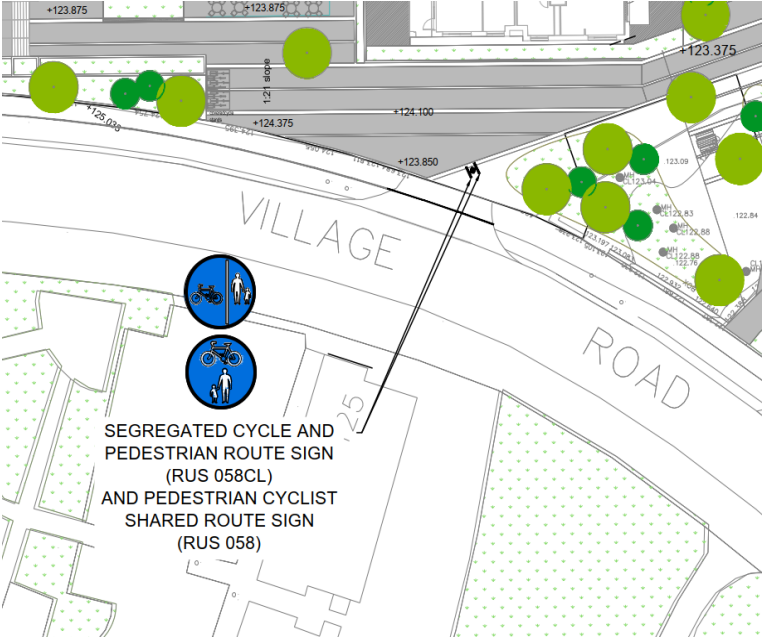
4.1.1.2 Problem	
Location	Village Road access
Drawing	Proposed General Arrangement
Summary	Transition/tie-in between footway, shared facility and cycle tack

<p style="text-align: center;">SEGREGATED CYCLE AND PEDESTRIAN ROUTE SIGN (RUS 058CL) AND PEDESTRIAN CYCLIST SHARED ROUTE SIGN (RUS 058)</p> <p style="text-align: center;">Figure 4.2: Access to site from Village Road</p>	
Description	
There is no clear tie-in/transition between the existing segregated pedestrian/cycle path on Village Road and the proposed pedestrian plaza or cycle lane. This may result in conflicts between pedestrians and cyclists at the site access from Village Road.	
Recommendation	
There should be clear definition and tie-in between the cycle track and footpath on Village Road and the Shared Space through the scheme.

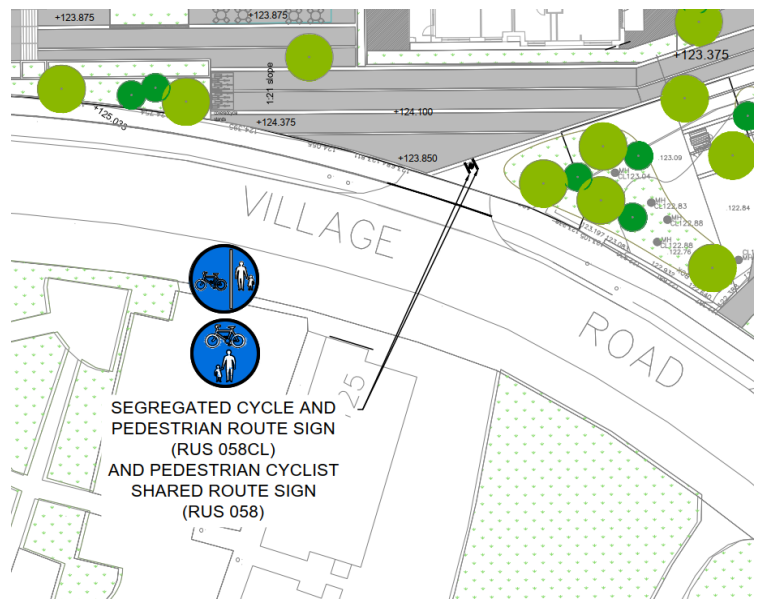
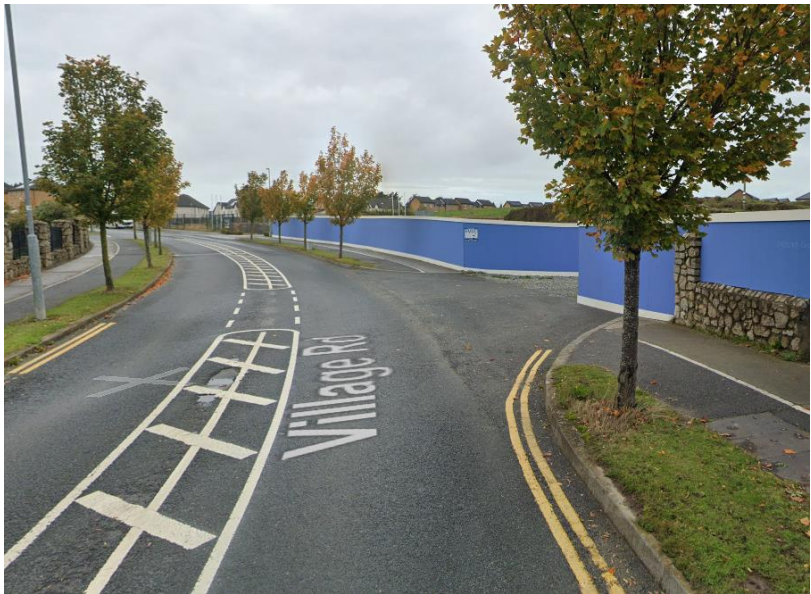
4.1.1.4 Problem	
Location	Village Road access
Drawing	Proposed General Arrangement
Summary	Facilities for Cyclists through the junction

<p style="text-align: center;">Figure 4.6: Atkinson Drive / Village Road</p>

<p style="text-align: center;">Figure 4.7: Village Road (Google Image)</p>	
Description	
<p>It is unclear what is proposed for the existing bell-mouth site access to the site. Should the entrance be left as it is it may encourage motorists to drive onto the shared pedestrian and cyclists plaza of park in the existing bell-mouth which would be an obstruction for pedestrians and cyclists.</p>	
Recommendation	
<p>Cycle facilities should be provided through the existing access in accordance with the National Cycle Manual. The existing access should be closed off if no longer in use with appropriate kerbs provided.</p>

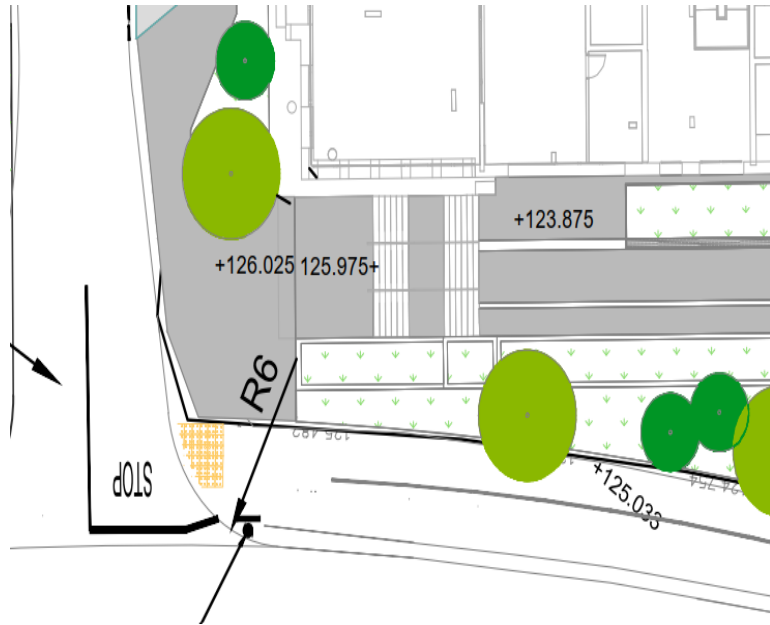
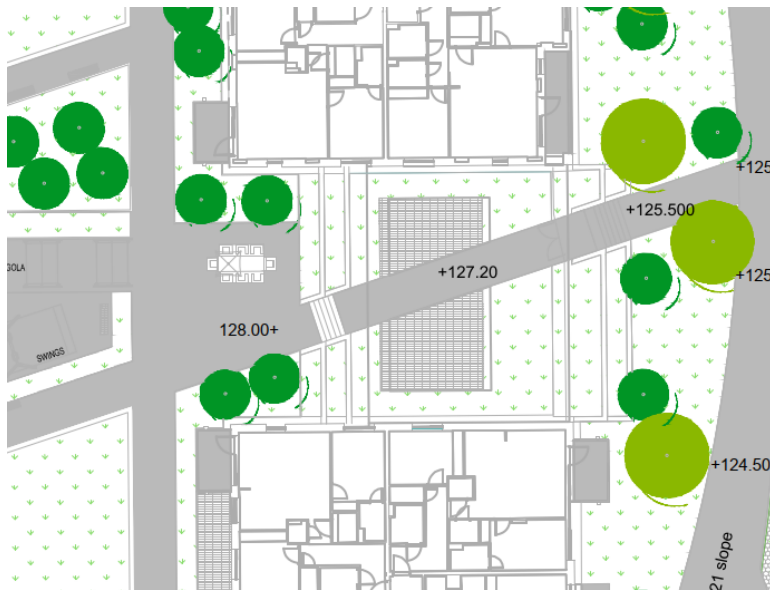
5.1.1.2 Problem	
<i>Location</i>	Throughout scheme
<i>Drawing</i>	Proposed General Arrangement
<i>Summary</i>	Steps provided without a ramp alternative

Figure 5.3: Proposed Steps

Figure 5.4: Proposed Steps

An alternative means of access should be provided, such as a ramp with appropriate gradients and handrails, in accordance with the *Building for Everyone*.

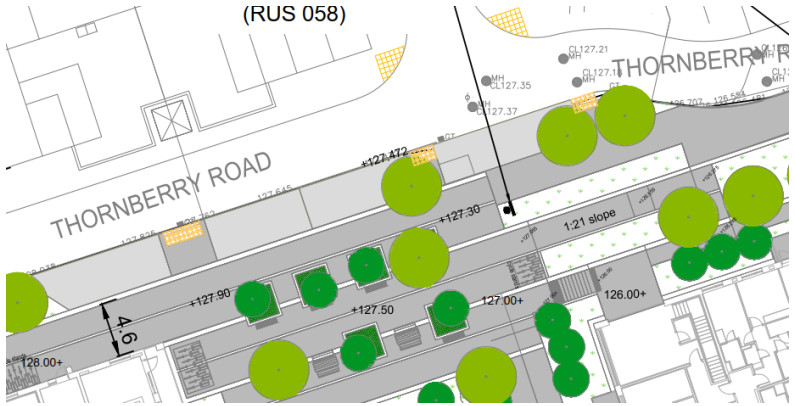
<p style="text-align: center;">Figure 5.5: Proposed Tactile Paving</p>
Location	Thornberry Road	
Drawing	Proposed General Arrangement	
Summary	No tactile paving on northern side of crossing	
Description		<p>Tactile paving is proposed Thornberry Road on the southern side, but there isn't a corresponding dropped kerb or tactile paving on the northern side. This may result in a trip hazard, in particular to the visually impaired, or resulting in accessibility issues for people using wheelchairs.</p> <p>Recommendation:</p> <p>Appropriate dropped kerbs and tactile paving should be provided on the northern side of the road carriageway.</p>

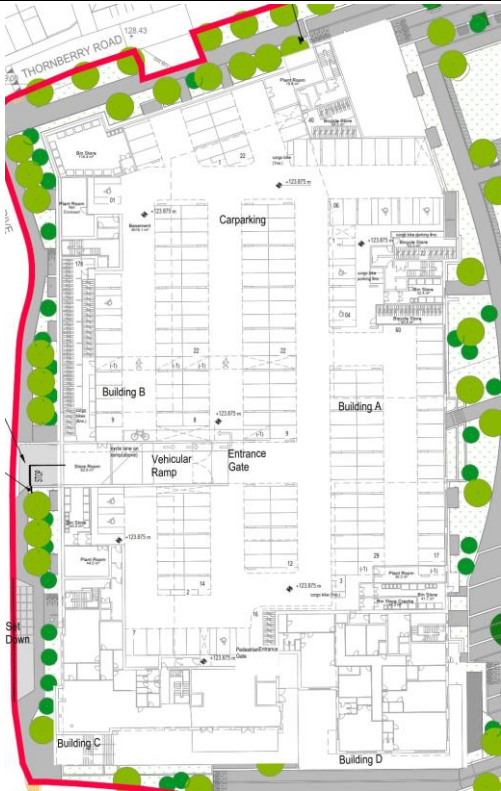
5.1.1.5 Problem	
<i>Location</i>	Basement
<i>Drawing</i>	Proposed Basement Arrangement
<i>Summary</i>	Mobility Impaired spaces located beside Elevators
Description

<p>It is unclear where the elevators are proposed in the basement arrangement. If mobility impaired spaces are not located close to elevators, some people may find the lifts difficult to use, such as the elderly and will result in a barrier for accessibility.</p>	
Recommendation:	
<p>Mobility Impaired spaces should be located close to elevators to allow for easier access to and from the main developments. Clear signage should be provided to highlight the location of designated parking spaces; ticket machines; lifts; or final exit</p>

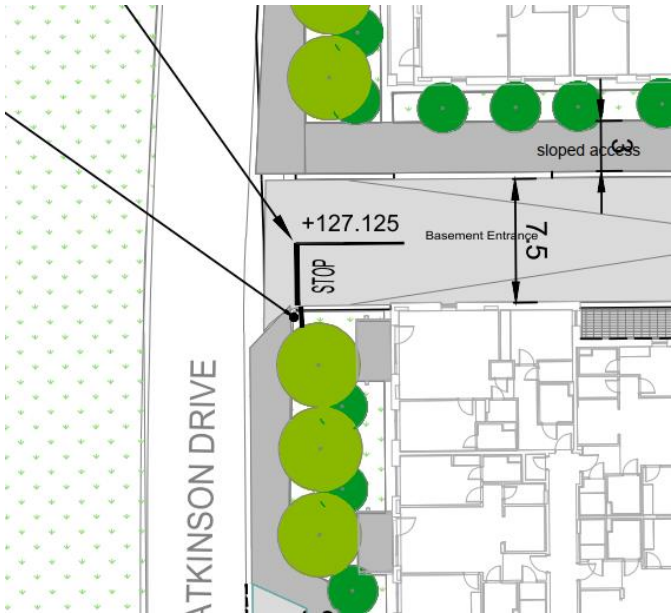
5.1.1.6 Problem	
<i>Location</i>	Basement Entrance on Atkinson Drive
<i>Drawing</i>	General Arrangement
<i>Summary</i>	No Tactile Pavement at Basement Access
Description

<p>No tactile pavement has been indicated at either side of the entrance to the basement car park off Atkinson Drive.</p>	
Recommendation:	
<p>Tactile paving should be added to either side of the basement entrance to assist with visually impaired pedestrian crossing the access junction.</p>

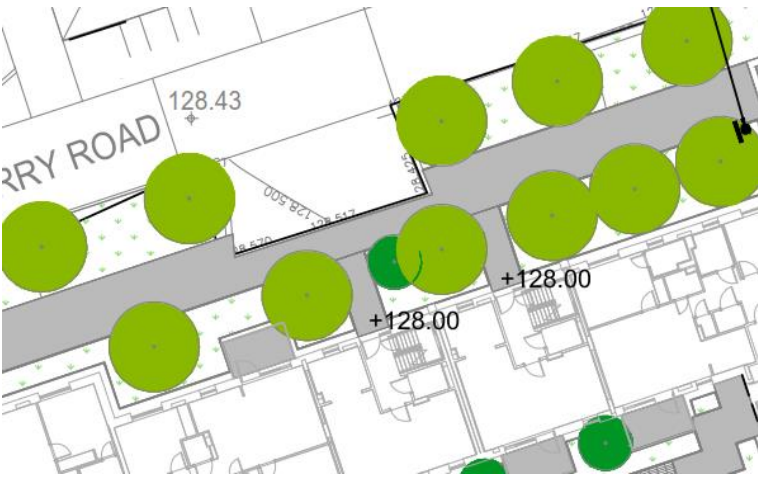
5.1.1.7 Problem	
<i>Location</i>	North West of Site
<i>Drawing</i>	General Arrangement
<i>Summary</i>	Footway on Thornberry Road
Description

<p>The existing perpendicular parking on Thornberry Road extends into the proposed footway. This presents a trip hazard for pedestrians as the footway leads pedestrians into the end of the existing parking area.</p>	
Recommendation:	
<p>The footpath should be redesigned to direct pedestrians away from the trip hazard of the kerb and the parking area.</p>

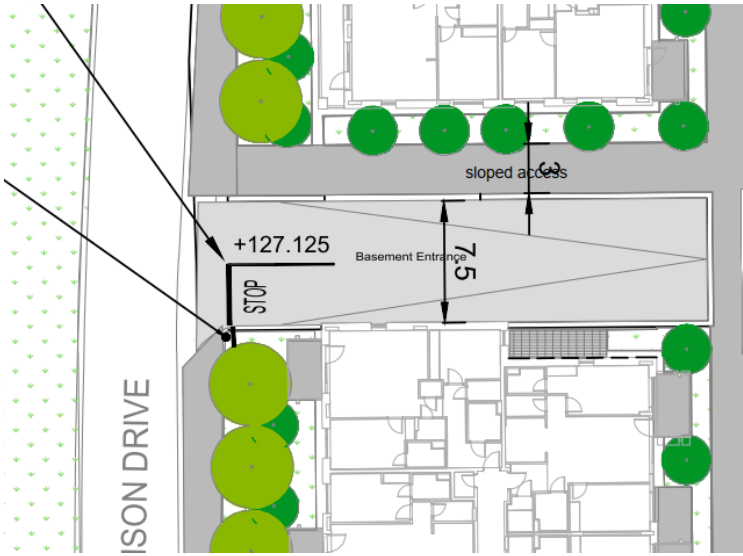
6.1.2.1 Problem	
Location	Vehicle access from Basement Car Parks
Drawing	General Arrangement
Summary	Visibility pedestrians crossing the development accesses

<p style="text-align: center;">Figure 6.1: Access to basement from Atkinson Drive</p>	
Description	
<p>Motorists should be able to see pedestrians crossing at the site access as the drive up the ramp due to its gradient. Furthermore, a wall appears to be proposed at the site access which will block visibility between motorists and pedestrians.</p> <p>Failure to provide appropriate visibility on the exit ramp could result in collisions with pedestrians crossing the access.</p>	
Recommendation:	
<p>Ensure appropriate visibility has been provided on the access ramp in both the horizontal and vertical planes in accordance with DMURS. The proposed wall should be lowered to ensure that pedestrians and motorists can see each other.</p>
